OMEGA

VRF

Trouble Shooting

VRF Error Table

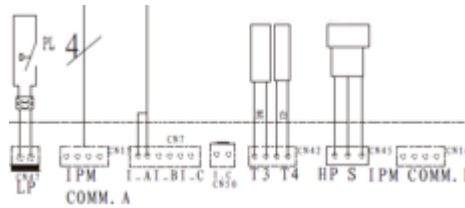
1. Measure the RST voltage using a multimeter to confirm if the voltage is 380V. If the voltage is not 380V, check the power supply and the voltage of the filter board. If the voltage is 380V, proceed to the next step.
2. Confirm that the connection wire between the module board and the main control board is not experiencing open current or short current issues. Make sure that the connection is firmly established.
3. To determine the reference voltage, first connect the multimeter to the middle port and GND or 5V on both sides. Then, observe the readings on both ends of the multimeter's DC gear. If there are fluctuations on both ends of the multimeter or there is no fluctuation at both ends, it indicates that the motherboard is faulty. On the other hand, if one end has fluctuations and the other end has no fluctuations, it suggests that the module board is faulty.

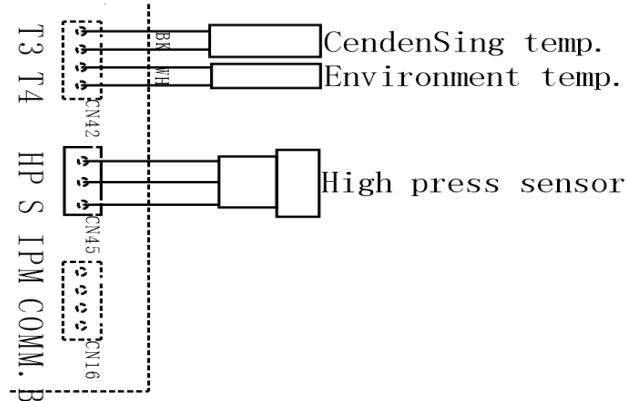
1. Please examine if the pressure sensor is tightly attached and ensure that the connection is stable.
2. If the aforementioned steps do not identify any issues, it is recommended to replace the pressure sensor or main control board.

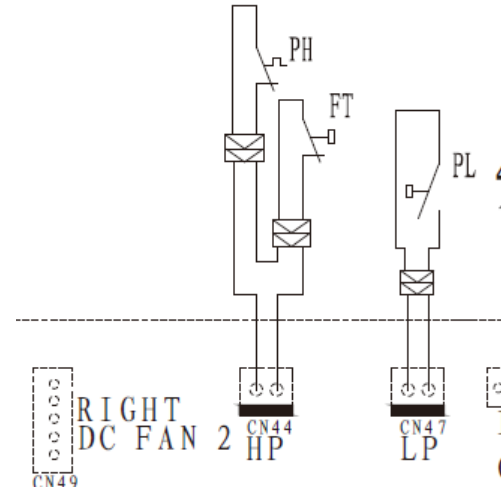
4. Please connect a pressure gauge, run the unit, and verify the high and low pressure readings. If the pressure readings are within the normal range, remove the pressure switch and measure its resistance. If the resistance is infinite, replace the pressure switch. However, if the pressure switch resistance is 0, replace the main board.

5. When connecting the pressure gauge for testing, if the pressure reading is too high, it indicates a system issue. To resolve this problem, you will need to troubleshoot potential issues such as blockages within the system, vacuum problems, and excessive refrigerant.

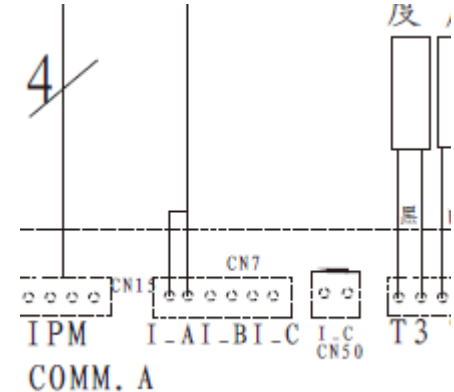
2. Please verify if the current transformer is securely connected
3. Please use a clamp meter to check the primary side AC current and the secondary side compressor DC current and inspect items 32/33/34/35. Compare the difference between the measured value and the clamp meter reading. If the difference is significant, it indicates a problem with the current transformer or the main control board. Attempt to use a normal transformer to resolve the issue. If the issue is not resolved, then it is necessary to replace the main control board.

4. If the difference between the clamp meter reading and the checked value is not significant, then it is possible that the issue lies with the compressor or the system. Further inspection and troubleshooting may be necessary to identify and resolve the problem.

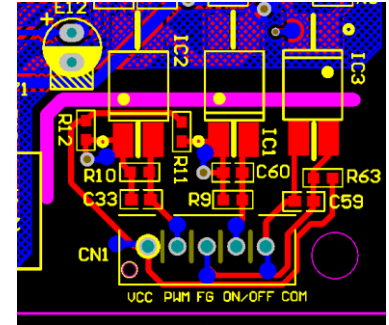
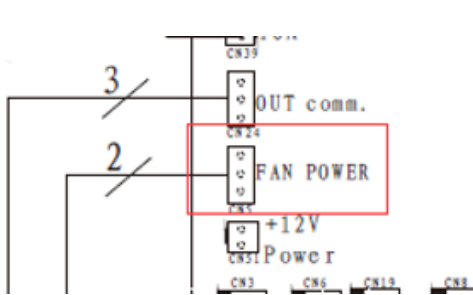
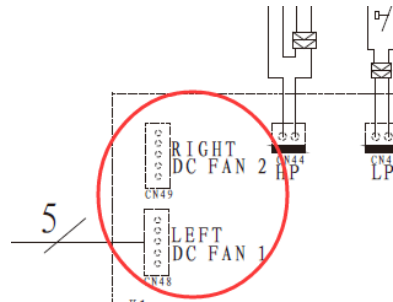
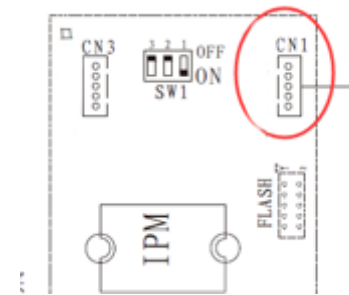
8. Measure the voltage between VCC and COM to verify that it is normally DC5V. If the voltage is not DC5V, the main control board should be replaced.
9. Measure PWM-COM and verify that DC0V is off and that normal DC2.5V voltage fluctuates. If the voltage is not within normal limits, the main control board should be replaced.
10. If the voltages of VCC-COM and PWM-COM are normal and the issue persists, the module board should be replaced. If the problem still cannot be resolved, replace the motor.

The communication port connects with the main board.
The power ground is connected to COM.
The fan start signal is controlled by Ctrl.
The signal for starting the fan is 0V, and for closing it is 5V.
The fan speed feedback is indicated by FG.
